Flood damage assessment of vulnerable area in Riyadh city, Saudi Arabia (case study: Al-Thumama Bridge)

Ibrahim. H. Elsebaie

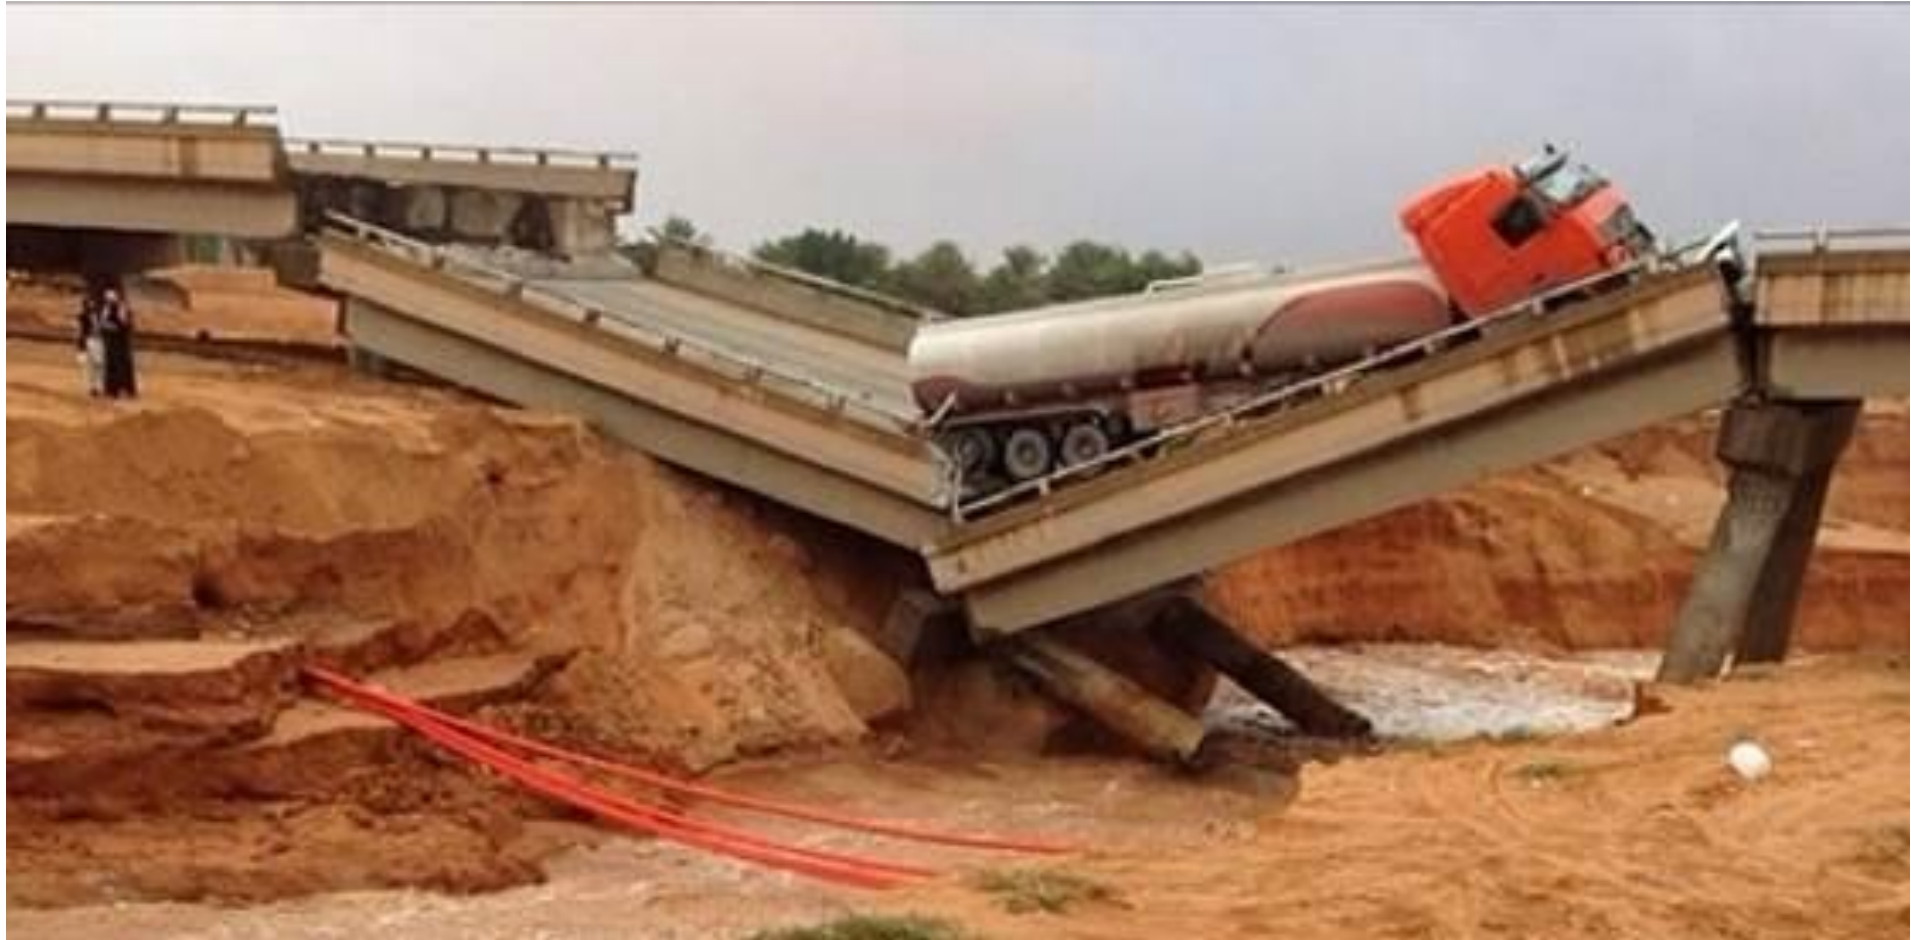
Figure (1) : The Failure part in Thomam Bridge

- The flood damages happened at Thumama Bridge were due to one of the heaviest storms that hit Riyadh city in November 2013. The storm in whole Riyadh caused an evacuation of people in danger and then sheltering them. Riyadh city is considered one of the cities are vulnerable to flood risk in Saudi Arabia due to urbanization and recent development as well as climate changes

The bridge was vulnerable to flood damages in 2013 and led to bridge failure. The bridge consisted of 13 openings with a total length of 195 meters

- The study has shown significant values of the scour depths at the bridge piers due to the high water velocities under the bridge which happened during the storm event.
- This problem may lead to the bridge collapse if those values of the scour depths did not take into account during the bridge design .
- So the study recommended taking into account the expected scour depth which obtained from the hydraulic modeling which guides the designer to use deep foundations at the piers of the bridge.
- Also, it is recommended to use some accessories or devices in the stilling basin to dissipate the energy at the downstream of the valley.
- Also, it is recommended to strengthen the soil type of the bed to match it with the calibrated value of the roughness coefficient used in the modeling to reduce the flow velocity and hence dissipate the high kinetic energy which causing much scour.

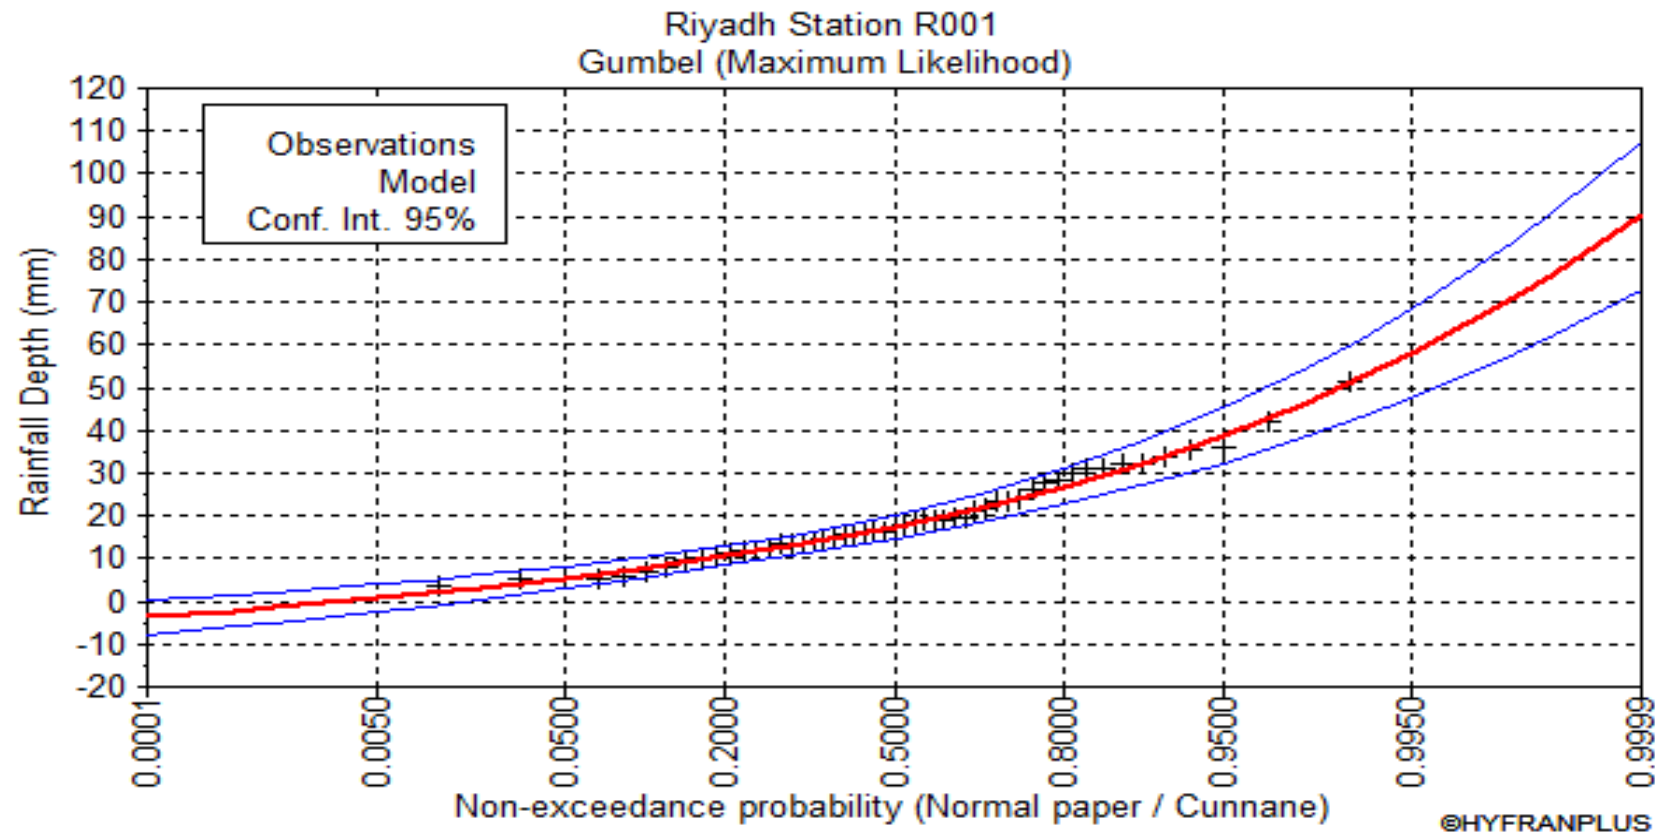
Figure (3): Gumbel fit of maximum daily data of Riyadh station (R001)

- Meteorological analysis
- Updated the IDF Curves for Riyadh station

- The prediction of rainfall depths for 50 and 100-years were estimated to be 46.5.6 and 52.2 mm, respectively. ...
- The methodology of SCS-CN method was performed to estimate the peak flows at the catchment outlet point to be 256.0 m³/s and 291.0 m³/s for 50 and 100 years return period respectively
- The weighted Curve Number value of Wadi basin was estimated to be 81
- In the hydraulic modelling, the Manning roughness coefficient was increased to 0.03 (Earth channel-weedy) to dissipate the energy at the Baffles and drops.
- The scour was estimated assuming that the valley cross section does not tolerate the high water velocities.
